# JORDAN RIVER CHANNEL STABILITY EVALUATION

STREAM REACH INVENTORY  
AND  
CHANNEL STABILITY EVALUATION  
FOR  
THE JORDAN RIVER IN SALT LAKE COUNTY, UTAH

STEVEN F. JENSEN, M.P.A.  
ENVIRONMENTAL PLANNING COORDINATOR

NOVEMBER, 1986.

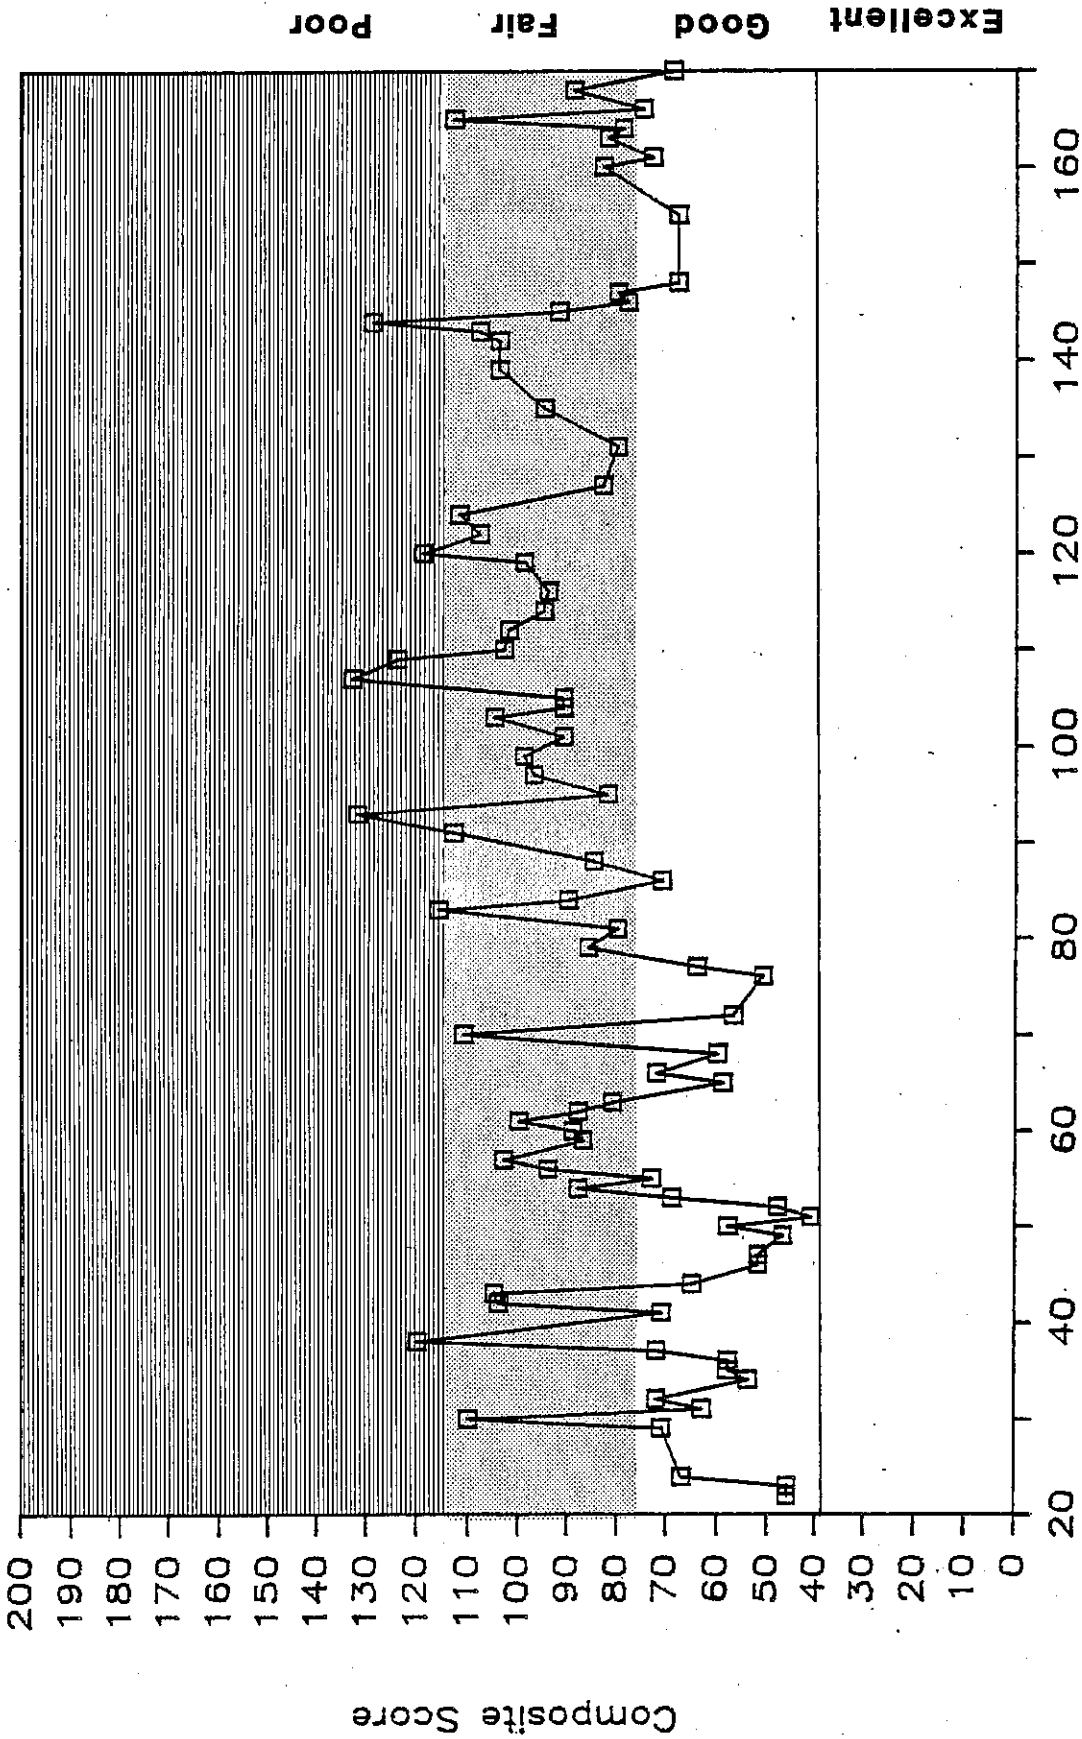
Figure 6

Figure Six summarizes all channel stability rating factors together in a composite graph. All of the factors provide an index of general conditions within the study area. Total point ratings are plotted at each river reach and segment station. As indicated on the graph, the mean conditions appear to improve as the river flows downstream into the Midvale and Murray area. Some river reach conditions in the downstream section are fair to poor and produce some inconsistencies, but in general the conditions from 2100 South upstream to 5300 South are rated good, while those above 7800 South are fair to poor.

Within the total point distribution, 53% of the river reaches fell into the "fair" category, while only 8% were classified as "poor." None of the river reaches rated high enough to be "excellent," and 39% of the reaches rated "good." The largest distribution of "fair" ratings appears above or upstream of 5300 South, although the reach between 6400 and 7800 South scored very high or rated "good." This is an anomaly caused principally by the 6400 South Bridge which constricts the river flow and reduces velocities upstream, thus reducing bank and bed scouring.

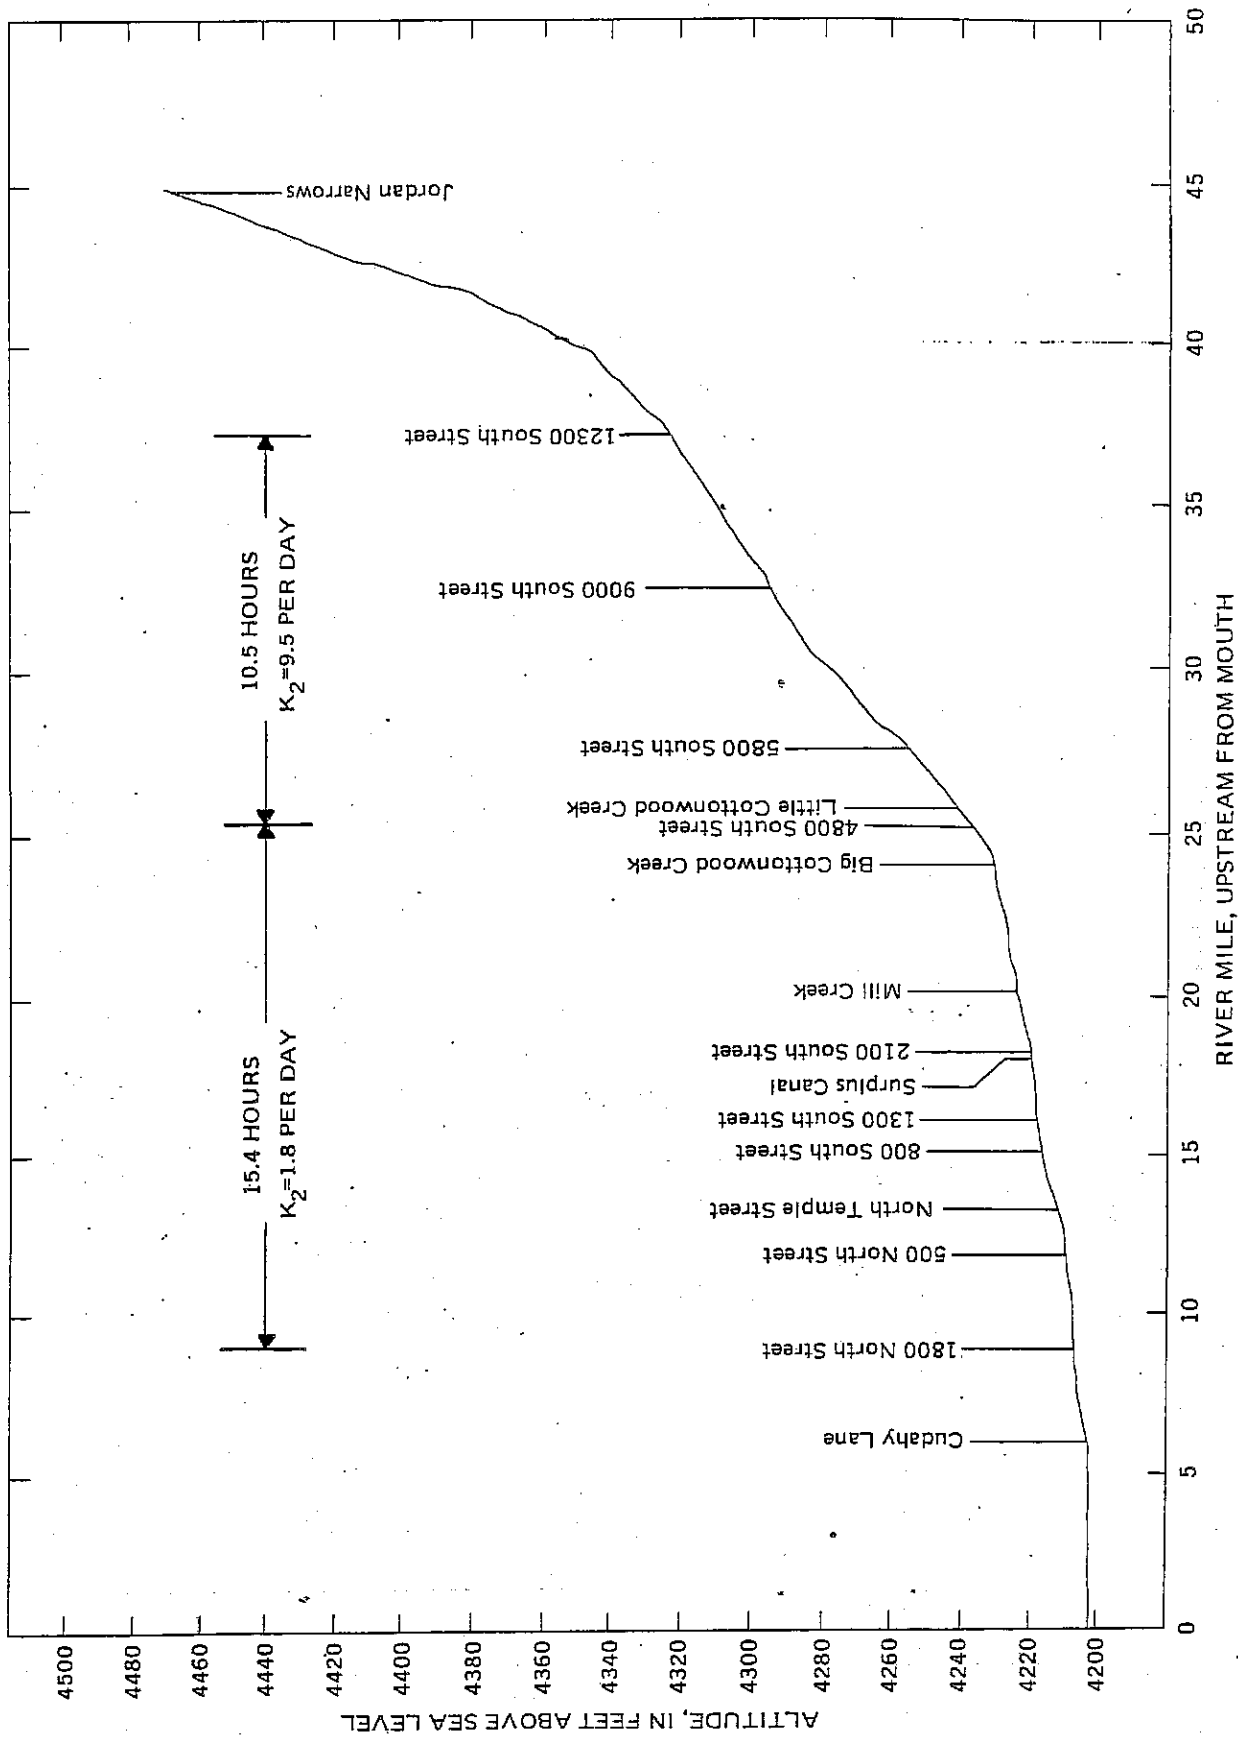
Figure 7 --Profile of the river channel with selected reference points, travel times, and reaeration rates ( $K_2$ ). Modified from Stephens (1984).

It is concluded that river gradient is most responsible for the high incidence of "fair to poor" distribution (See Figure 7). As the Jordan loses gradient, there appears to be a close correlation with increase in bank stability conditions. This pattern is to be expected. However, some anomalies in bank stability appear within Segment X below 4500 South, Segment XI below 3900 South, and Segment XII below 3300 South. These anomalies are believed to be the result of recent and frequent in-stream dredging at these locations, which artificially increases stream velocity and bank/bed erosion. The same pattern occurs above 9000 South and 10600 South. The constriction at the 6400 South Bridge, while maintaining stability upstream, has produced severe (probably the worst observed on the lower Jordan) bank cutting downstream due to high velocities surging from the constriction. This pattern also seems evident below major bridge crossings.

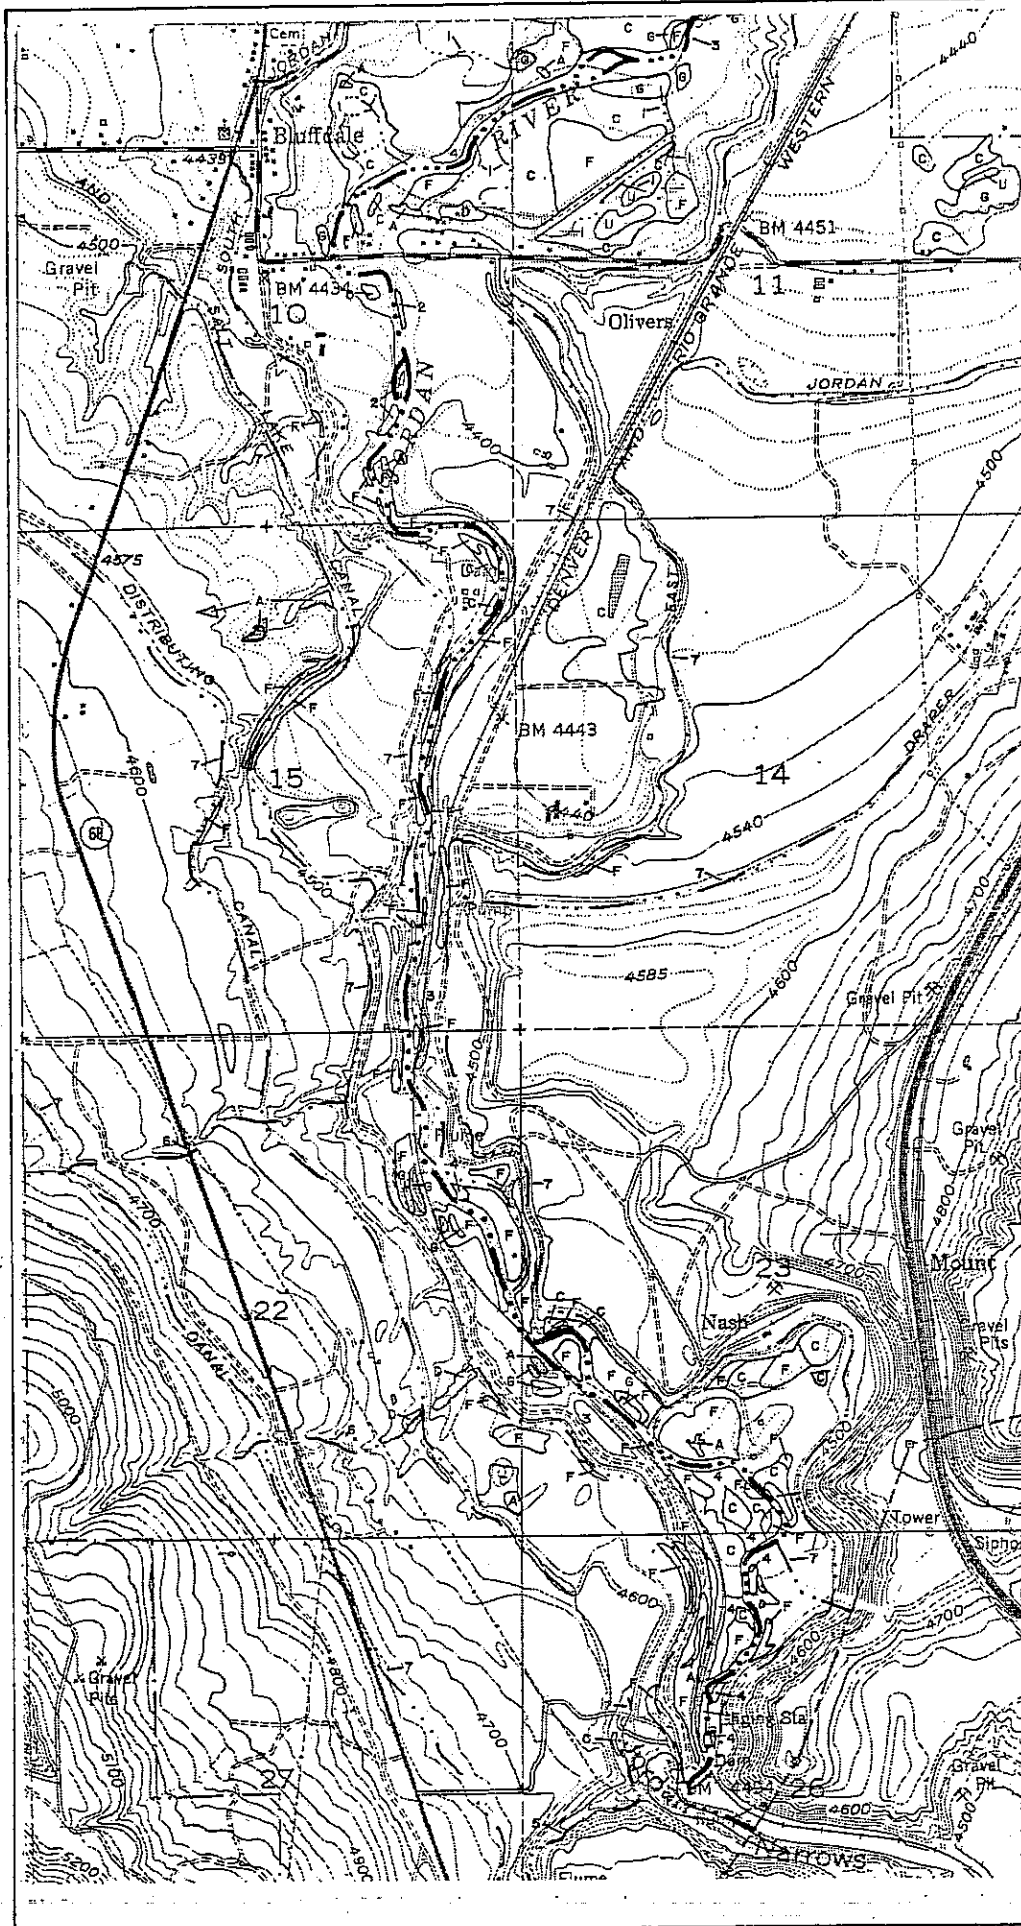
Figure 12

SUMMARY/CONCLUSION. Segment I is among the highest rated six river segments on the Jordan, although it possesses the highest stream gradient. Five reaches score "good" with remainder "fair." The stability of this segment is due primarily to flood channels that store and attenuate high volumes and velocities.

REACH 1. From the Jordan Narrows downstream 1200' this portion has been channelled and rip-rapped. The riparian phase consists of less than 10% cottonwood, but adjacent floodplains exhibit more than 50% willow and cattail wetlands. No oxbows or springs were evident. Upper bank slopes average 30%-40%, but good vegetative bank protection rated the reach low for mass-wasting hazard. The reach displays excellent bank-rock content, due mainly to rip-rapping. Lower bank cutting and deposition were generally absent.

REACH 2. The river forks into a complex of braided flood channels. The riparian phase is almost 100% oak brush, tamarisk, and willow. Grass-Sage occupies upland terrestrial communities. We encountered a large four-point buck in this reach. A large oxbow flood channel was apparent, and spring flow was evident from the East banks. Bank slope gradient was less than 30%, with excellent vegetative coverage and no mass-waste hazard. Cutting and deposition were not observed. This reach has a high sediment buffer/trapping potential.

REACH 3. Another complex, heavily vegetated flood channel system, this reach is unique in its riparian phase consisting of box elder and cottonwood trees. Thick tamarisk, willow and olive shoots are emerging in the wetland and floodplain. Three large Does and a yearling Fawn were observed in this reach. The area is the site of a Boy Scouts of America Camp, and a possible Section 404 Violation seems apparent along the Northern edge of the reach. Both oxbow/meander flood channels and spring discharges were observed. Bank slope gradient was less than 30%, with excellent vegetative bank protection and low mass-wasting hazard. Bank rock composition was fair, but little cutting and deposition has occurred.

REACH 6. Another short, constricted river reach with indications of a broken diversion or instream obstruction than has created head-cutting. Similar to Reach 4, the site has steep banks, high mass-wasting hazard, but still good conditions on the lower banks for cutting and deposition.

REACH 8. Constricted on both banks, this reach has been extensively stabilized with rip-rap at its upper end. Some spring discharge exists. Several fishermen were observed on three visits to the area. Mass wasting hazard exists on the lower reach where slope of banks increases and vegetative bank protection is only fair. No serious cutting or deposition.

REACH 9. This reach is well over a mile in length. It is a narrow, constricted channel that has been extensively stabilized by rip-rap. Railroad trestles on the East and TWO irrigation canals enclose the river along this steep, rapid stream portion. Some springs observed emerging from West banks of the river and canals, adjacent to bedrock outcrops. High bank slope gradient is off-set by good bank vegetation. Low future potential for mass-wasting, cutting, or deposition.

REACH 10. The Jordan River widely bends Westward at this reach, with drowned Olive and assorted shrubs (including HUGE growths of Poison Ivy) comprising the overstory, and good cattail growth in the understory. There has been an extensive fill with attendant bank stabilization on the West end of the reach. Spring discharge was observed. Banks generally less than 30% kept mass-wasting, cutting, and deposition low, together with thick vegetative bank protection on both sides of the channel.

REACH 11. This reach is being modified by limited filling & bank stabilization. Russian Olive provides good bank protection, with some oxbow meanders and wetlands enhancing the condition. Good bank rock content and gradients have kept cutting, deposition, and mass-waste hazard low. Filling of East bank flood channel may create problems. Rip-rap downstream near bridge has eliminated any future concern for this reach.

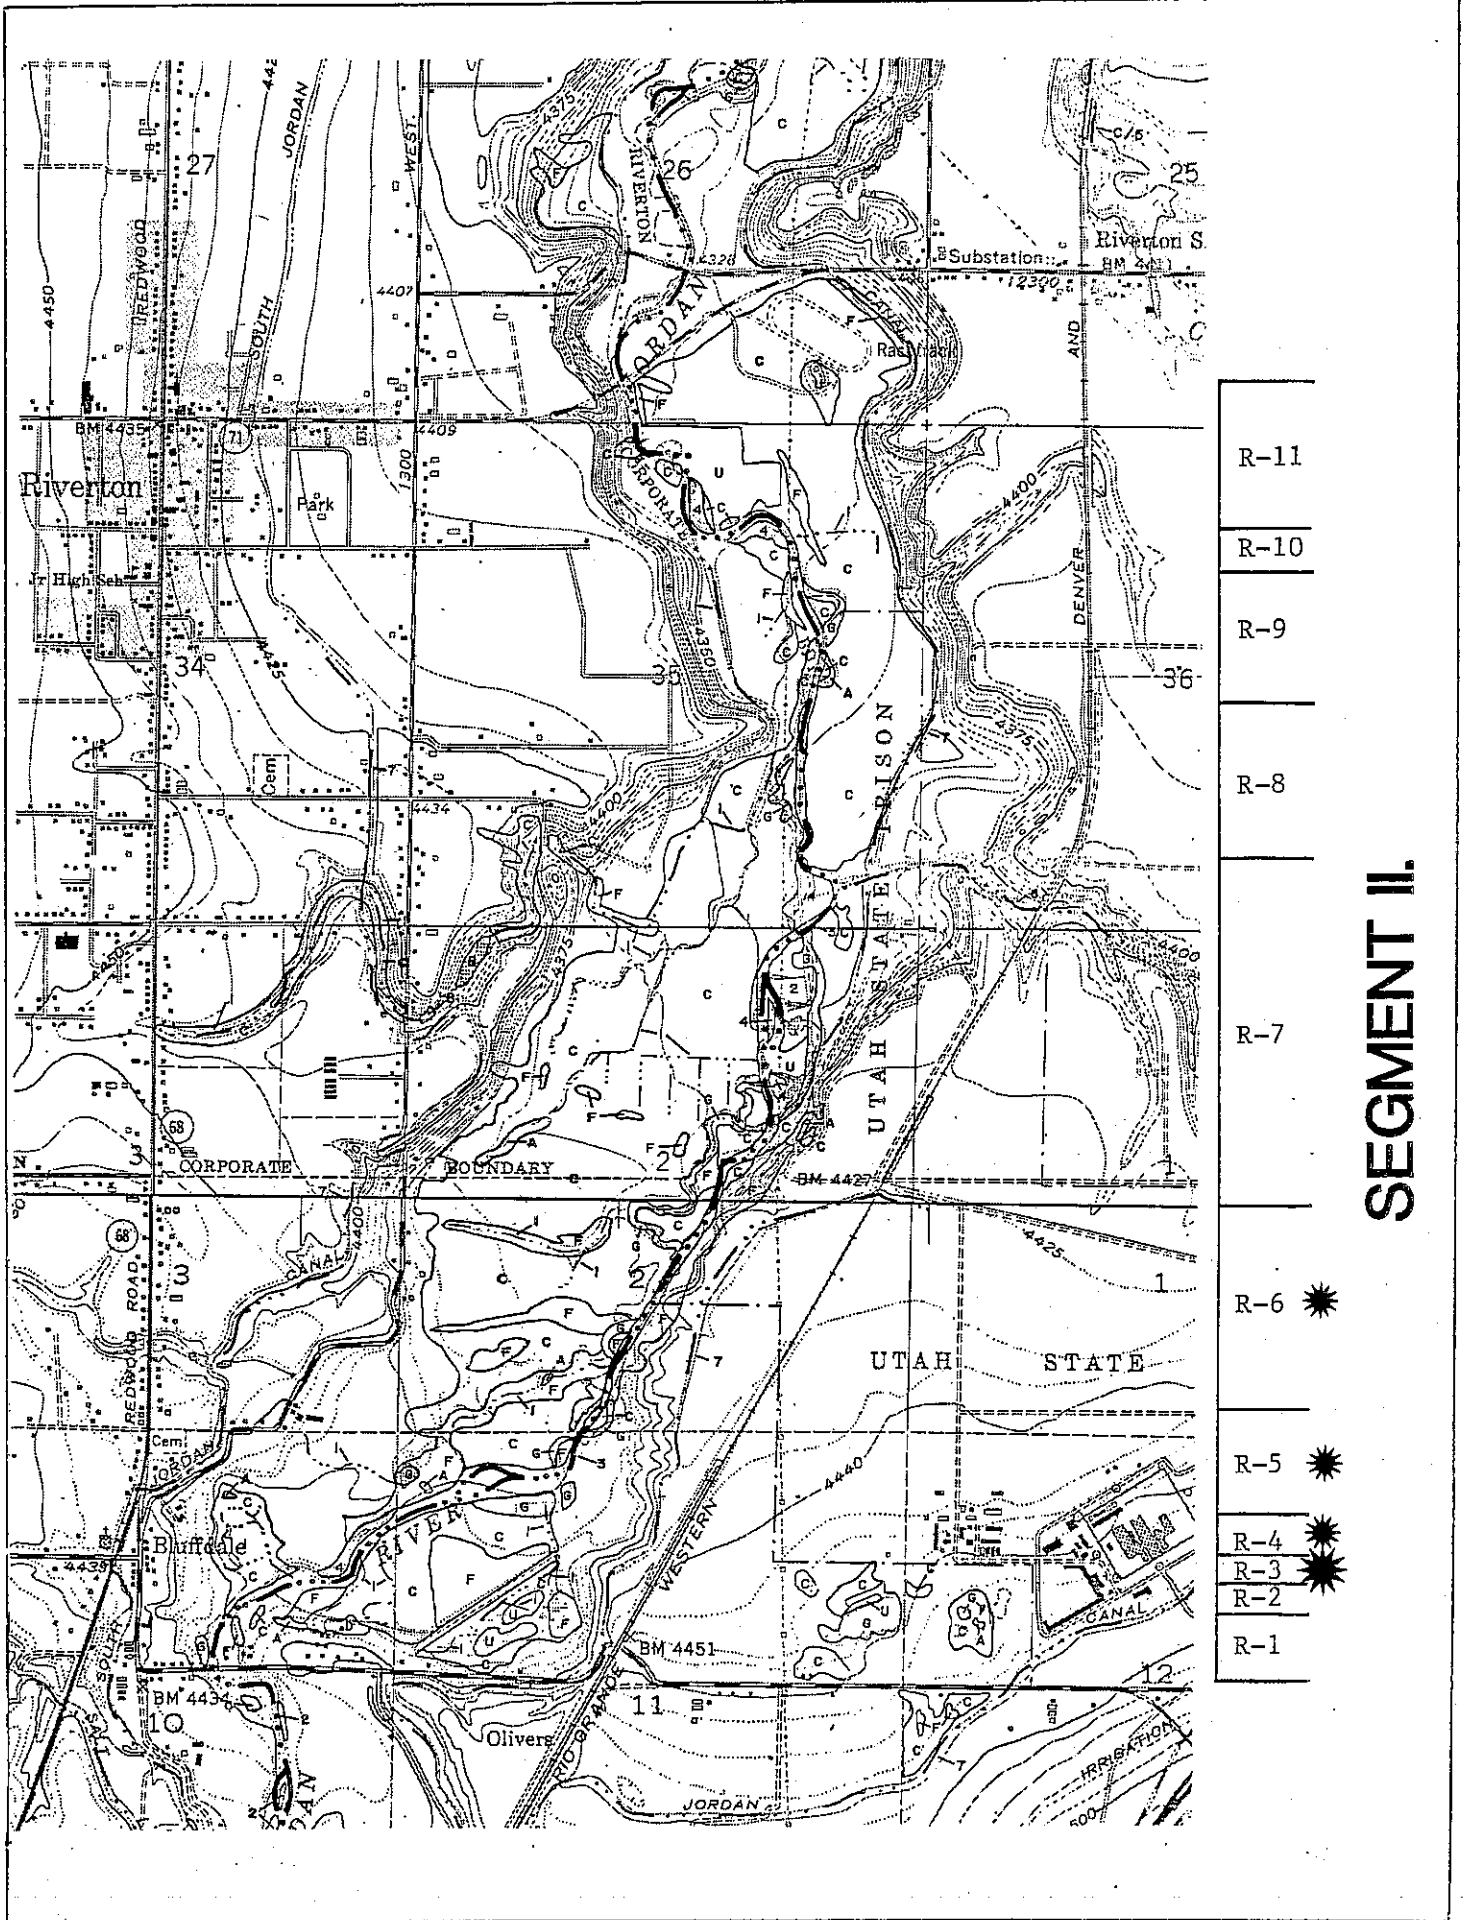
Figure 13

SUMMARY/CONSLUION. Segment II Reaches all ranked "fair" with exception of Reach 4 which ranked "poor." The reach contains fifteen oxbow meanders and at least sixteen spring discharges. Many bank slopes exceed 40% and cutting & deposition are common. Mass-wasting hazard is high, bank rock content fair to poor. Vegetative bank protection was best at oxbows and meander channels. The reach possesses very unique habitats and supports a diverse wildlife population. It is second only to Segment I in natural amenity and beauty.

REACH 2. The Riparian phase is 15% Russian Olive, while the floodplain is 80% grasses and 20% trees. Moderate sediment trapping and deposition in West bank meander. Spring discharge evident. Fair bank slopes & mass-wasting hazard. Poor vegetative bank protection. Willow cuttings could be easily placed at this Reach.

REACH 3. Riparian & floodplain phase similar to Reach 2. No oxbows, meanders, or spring discharges evident. Average bank slopes above 60% with little or no vegetative bank protection and high mass-wasting hazard. Severe cutting and deposition occurring with extensive and hazardous bank undercutting.

REACH 4. Poorest rated Reach in Segment II. Possesses same characteristics as Reach 3 except WORSE. Severe bank cutting between 5'-7' high on East bank. Hazardous to stock and humans. Grading-back slopes with rip-rap tows and revegetated banks are recommended. Emergent wetland plants are initiating the bank stabilization process in the East bank meander. Numerous shore and wading birds.

REACH 5. This 3800' long reach is very unique in the extensive braided channel, bank cutting, and isolated meander ponds along the East banks. At least four oxbows and elevated meanders receive discharge from three springs. The Riparian Phase is dense and diverse with large Olives and other unidentified trees along the elevated banks. Five pairs of nesting Night Herons were observed in the quiet, isolated aquatic bedss of the East banks. A small flock of Black-faced Ibis were feeding in the pond area. A truly unique recreational experience, the elevated banks form a natural "nature trail" or path along the isolated ponds, rich in insects, wildlife, wetland plants, and wildflowers. Below, vegetative bank protection is excellent, but the river gradient and direction are producing extensive hazard of mass-wasting, cutting, and deposition.

REACH 7. This expansive depositional reach is perhaps one mile in length. The widest flood channel is about 800' with little or no riparian vegetation. The Eastern banks and floodplains are heavily grazed. Three large oxbow meanders have recently formed and are fed by three discharging groundwater sources. The springs are used heavily by grazing stock, and are fast becoming polluted. Banks are generally less than 30% and vegetative bank replacement is beginning following the severe effects of past floods. This area is a good candidate for slope-regrading and vegetative replacement using species NOT desirable by cattle--if such a thing exists.

REACH 8. This reach contains three old oxbow meanders and at least three spring discharges. Riparian phase is mostly Olive, with large isolated pockets of hardstem bullrush wetlands occurring in the floodplain. Nesting Night Herons were observed, together with many sitings of Canadian Geese, Snowy Egrets, Great Blue Herons, and large flocks of Black-faced Ibis. Apparently the wetlands are used extensively by unique wildlife species. Bank slopes are less severe, and cutting/deposition are absent. This reach has approached natural equilibrium due mainly to oxbow and floodplain storage of high flows.

REACH 9. This reach is characterized by four major bends and associated cut/deposit zones. The Riparian phase is principally Russian Olive, and wetlands in the floodplain are very diverse and widely distributed. Although grazed, both East and West bank floodplains are rapidly emergent wetland communities with large numbers of interesting plant types. New meanders and oxbow vegetation will be maintained by both river and spring flow. Banks less than 30% predominate, but two large mass-waste cuts on the West bank require immediate attention. A fair amount of deposition below the cuts testifies to the severity of the isolated cutting.

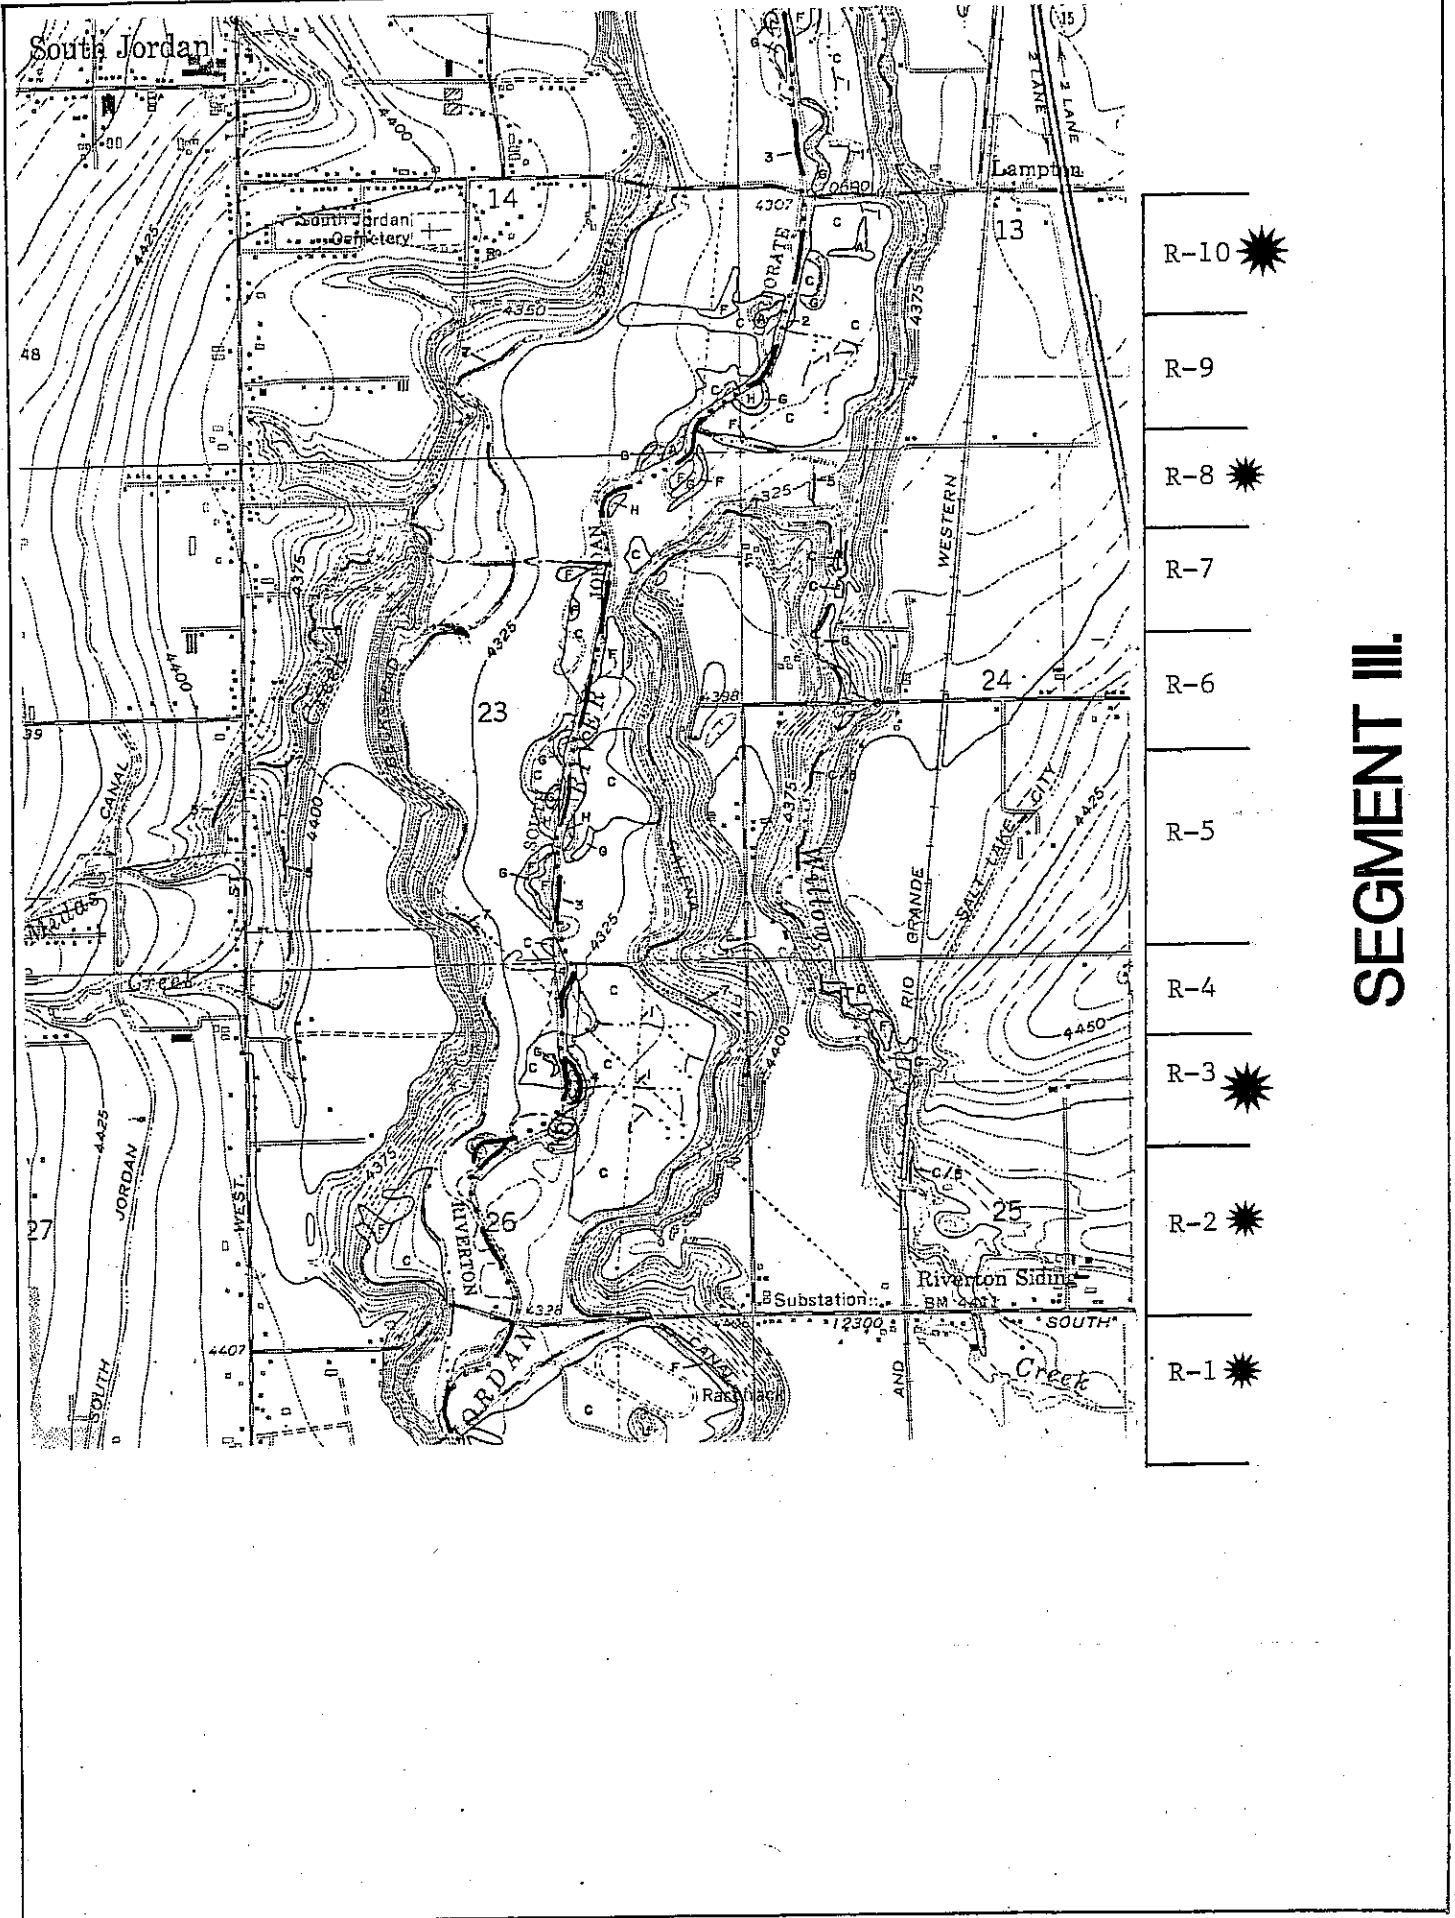
Figure 14

REACH 1. This reach is eroding badly. Riparian overstory is sparse except for a few streamside trees, mostly willow and cottonwood. Bank slopes exceed 60%, mass wasting hazard is high, bank rock content poor, and cutting producing 6'-7' high eroded banks. Bank re-grading, tow protection and overstory tree cuttings could effectively arrest the present condition.

REACH 2. Very sparse Riparian vegetation, mostly emergent tamarisks and olive. High bank slope gradients; good understory bank protection; poor bank rock content; poor cutting conditions; fair deposition. Sprig depositional areas with Tamarisk and grade-back Western banks.

REACH 3. Two oxbows and three spring discharges provide an increase in wetland diversity at this bending reach. Wide, 150' depositional areas have kept cutting on the East bank extreme and up to 20' high, placing a significant hazard before a valuable herd of dairy animals utilizing the East pastures. Mass wasting, cutting, deposition, bank rock content, and other factors are similar to those in Reach 2.

REACH 4. Of 15 rated factors, 9 scored "fair" to "poor." Minor oxbow benefits, but one emergent wetland oxbow does store and attenuate flood flows. Bank slopes are good with a 50% growth of bank vegetation. Rates "fair" in cutting and deposition. Flock of more than 100 Black-faced Ibis, 25 Canadian Geese, and a single Great Blue Heron observed in one afternoon, using mostly irrigated/inundated wetlands and pastures.

REACH 10. Conditions in Reach 9 are replicated here. Two Western oxbows have been cut off, and spoil mass-wasting and bank cutting is occurring at a rapid rate. Eastern flood channel meanders provide some storage and wetland benefit, but a dragline was busy on the day of observation moving toward the remaining wetland areas. Spring discharges are numerous, so both riparian and wetland vegetation could return with proper grading.
