**MILL CREEK RESTORATION PROJECT PHASE II: STREAMBANK
STABILIZATION INTERIM PROJECT REPORT**

January 1996

MILL CREEK RESTORATION PROJECT PHASE II: STREAMBANK STABILIZATION INTERIM PROJECT REPORT

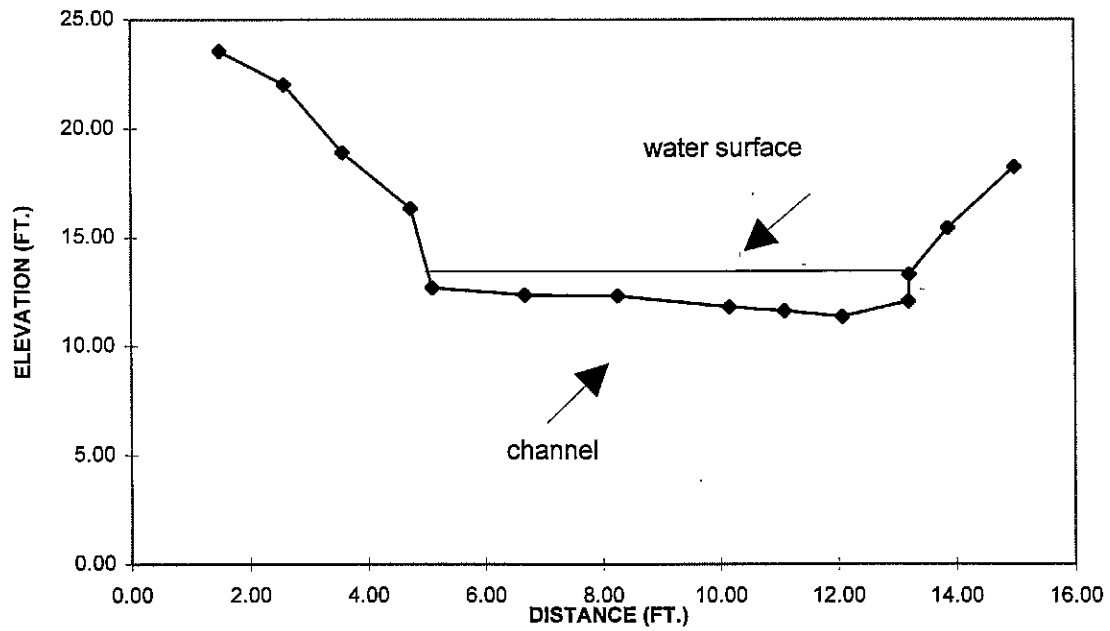
Mill Creek Cross Section II

Cross Section II was located on a cross over with a narrow thalweg adjacent to a steep eroding bank, a mid-channel sand and gravel bar and a riffle all represent this cross section. Therefore, the d50 and the d84 for this cross section is representative of these existing conditions. Severe imbeddedness was noted for 20% of the entire count and these results indicate, that there is a number of geomorphic variables to consider at this cross section. (See Cumulative Percent Finer vs Particle Size Plots in Appendix J.)

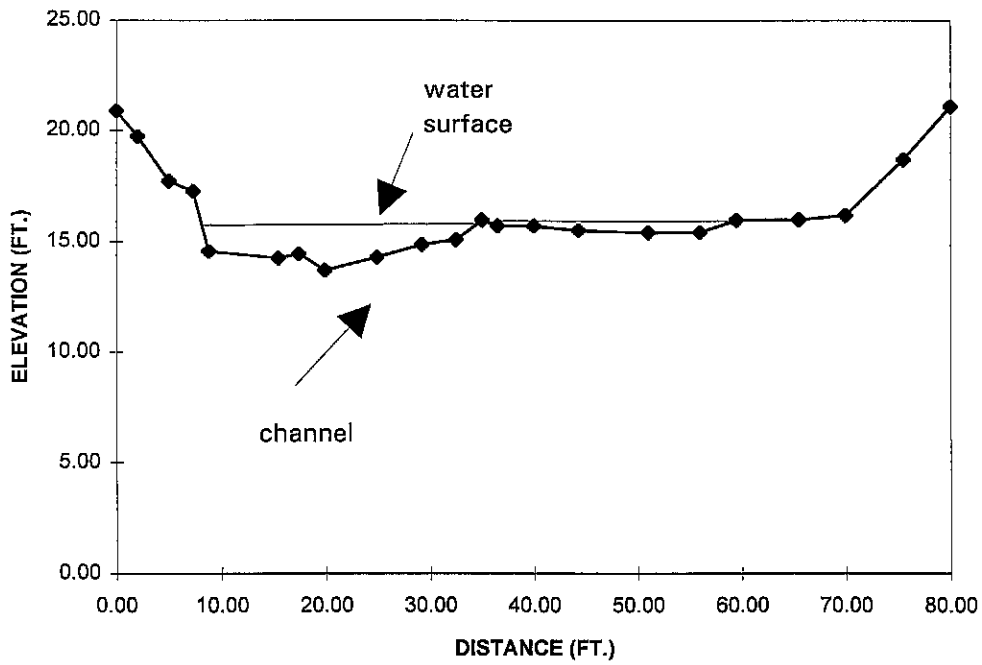
Mill Creek Cross Section VII

Cross Section VII is a wide floodplain area with a deep thalweg and small braiding channels across a several tiered sand and gravel bar. This explains the good mix of several different particle sizes found at this cross section. There was approximately 17% fines consisting of less than 6 mm at this cross section, which is the highest amount found in this substrate count analysis.

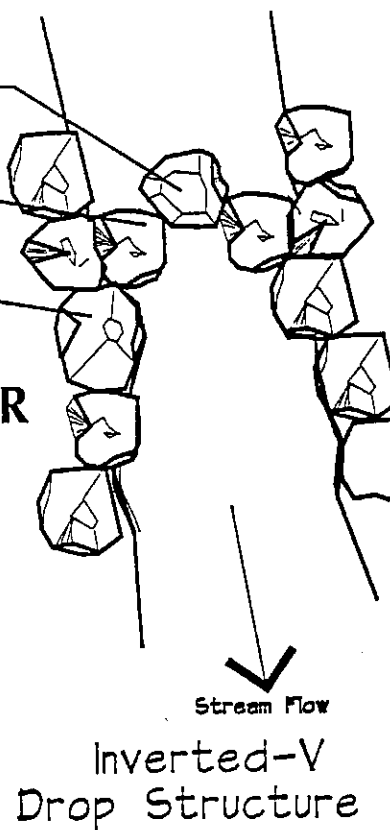
ROCK VORTEX WEIR

A Rock Vortex Weir design was utilized in this restoration project. (See Appendix K.) Mill Creek has a low width/depth ration and is considered a high bedload stream with sufficient sediment transport capacity. Other project evaluations have indicated that rock vortex weirs have worked well under these site conditions. According to Rosgen, Rock Vortex Weirs meet the following objectives:

Key first rocks on each side of the 'V' into the bank.
