CHANNEL STABILITY EVALUATION & STREAM REACH INVENTORY

SALT LAKE COUNTY DEPARTMENT OF PUBLIC WORKS

STREAM BANK STABILIZATION
INVENTORY FOR LITTLE COTTONWOOD,
BIG COTTONWOOD, AND MILL CREEK

SEPTEMBER, 1984

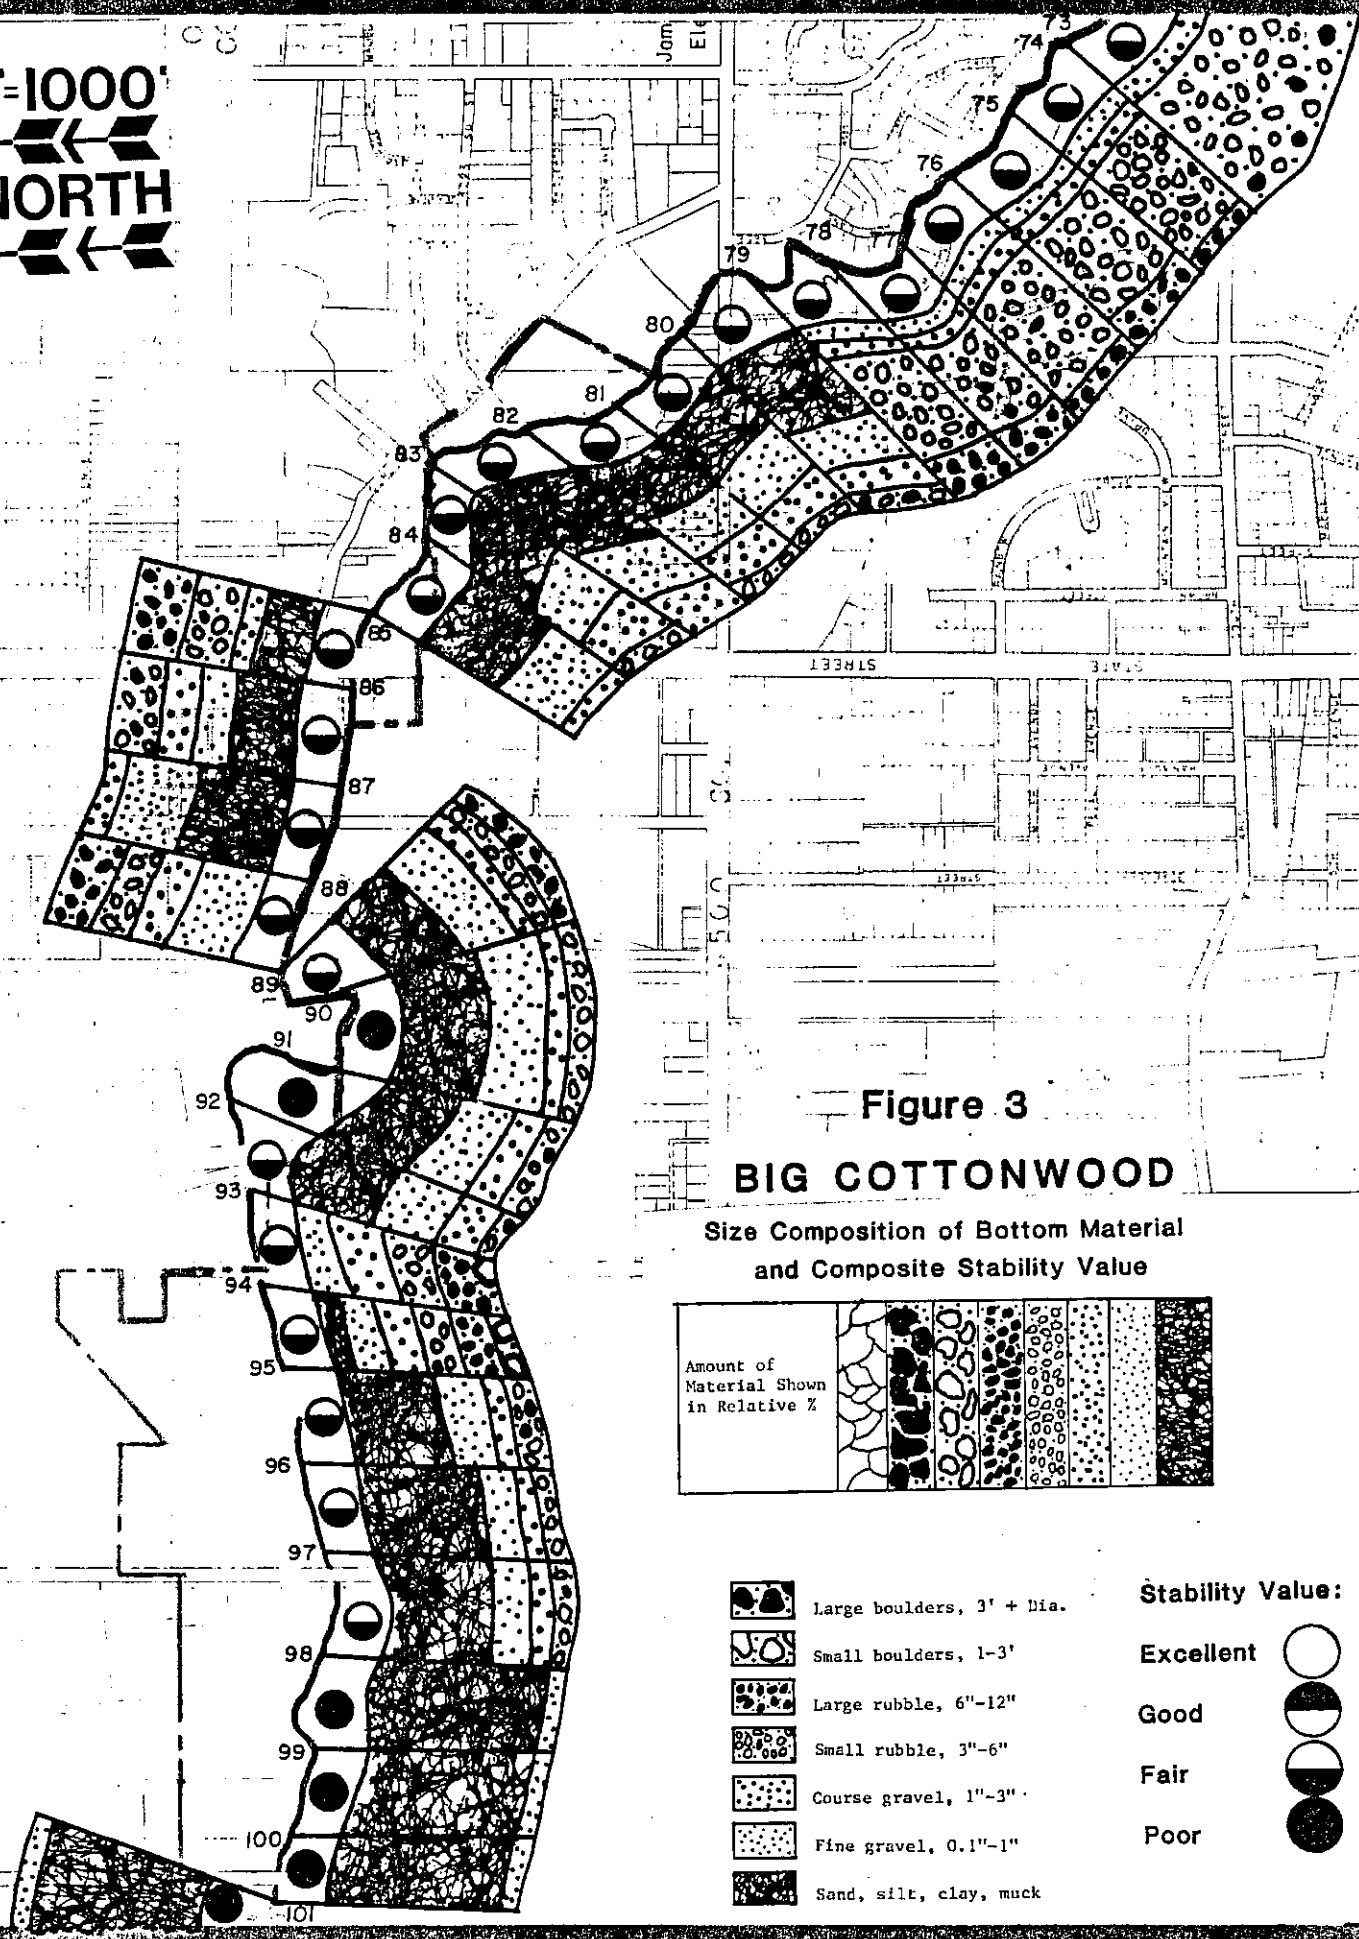
Identification of the size composition of bottom materials is normally a function of local channel gradient and stream velocity. Figure 3 shows the composition and size distribution of bottom material. Point differences may be due to micro creek gradients or man-caused movement. Generally, larger boulders were present but decreased slowly downstream and were virtually gone by point 17 (above Knudsens Corner Area). Extensive gabion construction below point 20 can account for the rapid disappearance of larger bottom material. Local available larger bottom material is utilized to fill gabion baskets. Additionally, channelization techniques push bottom material against the bank and subsequent bank erosion allows smaller materials to return to the creekbed prior to larger material. Rubble material (3-12 inches), too small to be utilized extensively as gabion fill material, predominates bottom material below Point 11, only to be placed by fine gravel and muck at Point 79 where the creek velocity slows considerably and dredging activities have taken place. Slower velocities allow smaller particles to settle out. Riffle-pool conditions, bridge and other road and development activities have affected size composition of localized creek segments.

Overall, the reach character scored 75 percent in fair condition, 9 percent in poor condition and 5 percent in good condition. Observations for 11 percent of the creek were omitted due to construction activities. The majority of poor conditions are found on the lower segments closer to the confluence of the Jordan River. Specific creek channel characteristics are found in Appendix A.

Bottom material mainly consisted of rock with sharp edges or rounded corners and edges. Sixty-two points identified rock angularity as either excellent or good. Only near the Jordan River confluence did rock angularity drop to the poor classification. Generally, rock brightness and aquatic vegetation was not a factor with most exposed bottom rock with bright surfaces. This is most likely due to channeling efforts as well as dewatering the creek. Most aquatic vegetation was found below storm drains and other outlets. Much of the creek bottom material consisted of a loose assortment with little overlapping. Only in natural undisturbed areas were tightly packed and overlapping bottom material found. A large range in bottom size distribution was identified (See Figure 3). However, stability was generally lacking. Only minor bottom scouring was identified and is not considered a factor. Major deposition areas were found at points 79 to 101.
