# the Watershed Watch

Newsletter of Salt Lake County Watershed Planning & Restoration

Winter 2017/2018, Issue 17

## Exploring restoration on the river

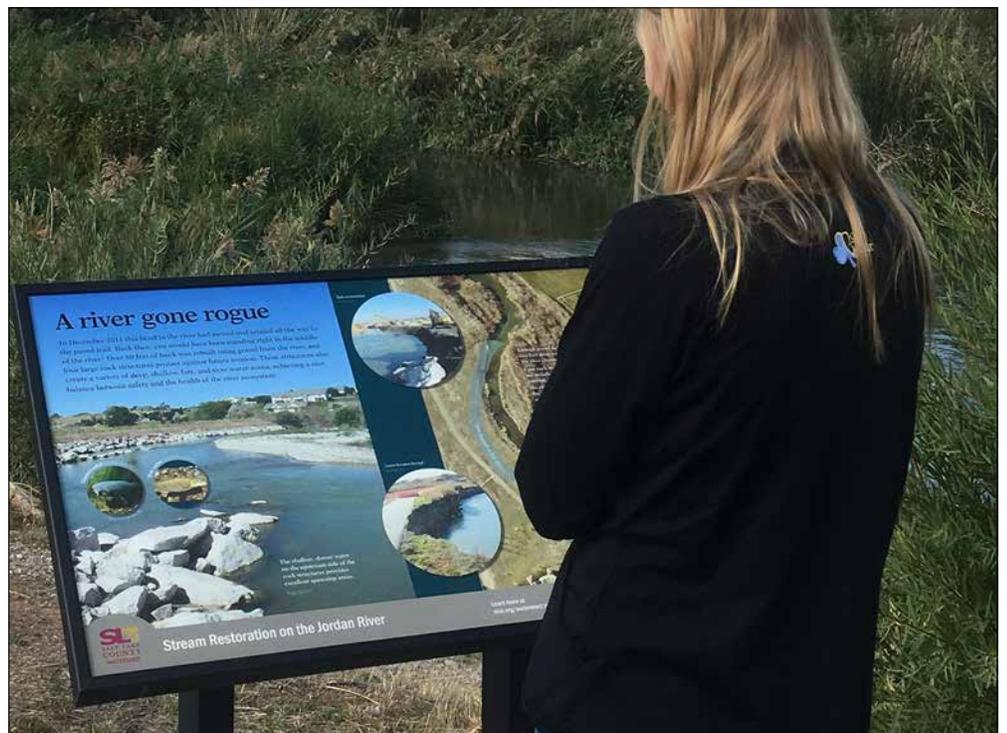
New interpretive sign discusses the major river realignment and bank restoration project completed in 2011 at Jordan River Rotary Park (12600 S). This project repaired erosion that was threatening to destroy part of the Jordan River Trail!

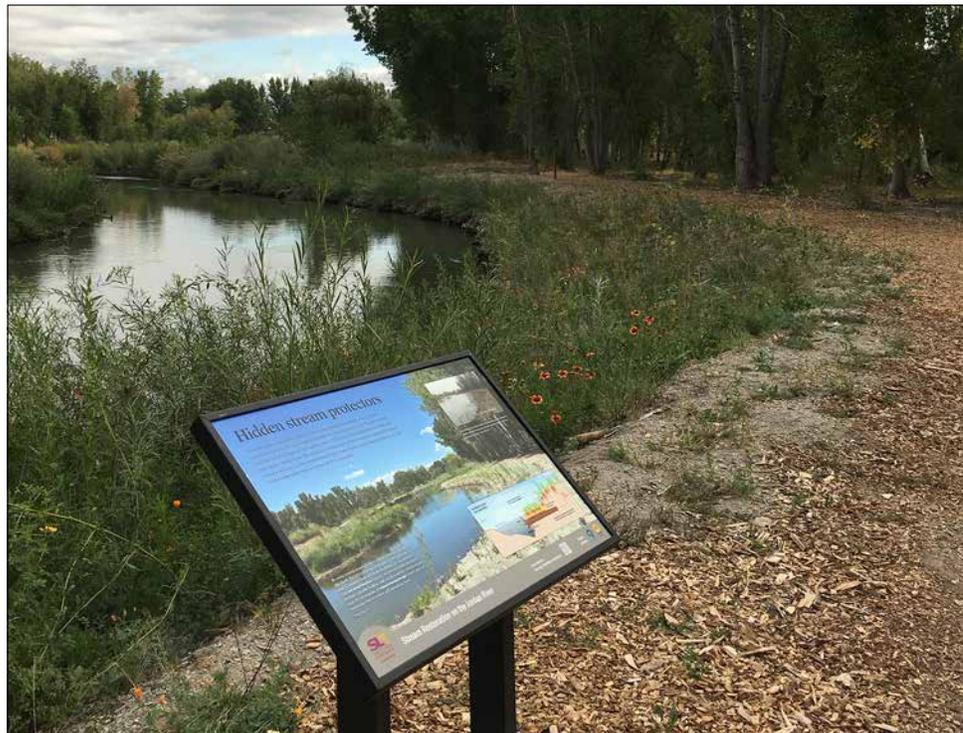
Once an aggressively eroding bank, native plants now thrive on this reconstructed streambank located at approx. 4850 S on the Jordan River. Deep roots stabilize the soils while stems and branches at the water's edge reduce floodwater energy.

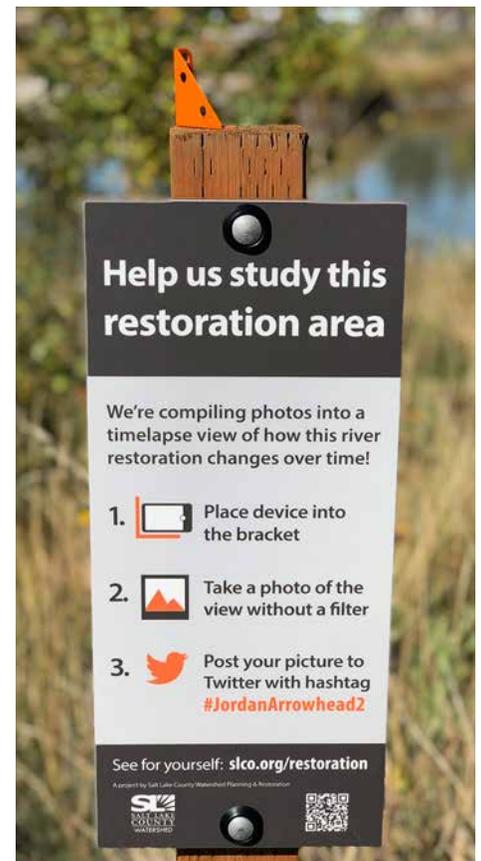
**Monitoring ecological change with smart phones and social media**

We're turning Jordan River Trail users into a remote sensor network! It's simple: Put up a sign asking people to set their cameras or phones in an angle bracket, take a photo, and post it with a site-specific hashtag to Twitter. Then harvest the photos and create timelapse views of change over time.

While developing the interpretive signs at our river restoration sites [see cover], we saw an opportunity to expand the project to include these "self-serve" photo monitoring stations. In a nutshell, we're encouraging trail users to get involved in the process of monitoring the restoration areas.

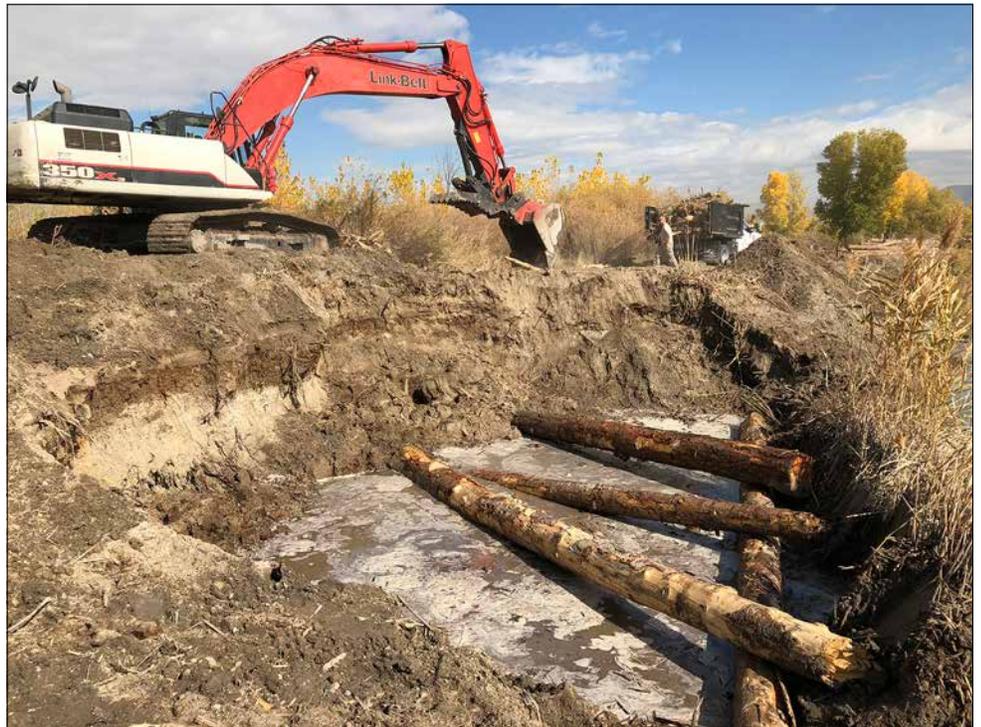
Over 150 logs were used to build the toe-wood structures in the Watershed Program's most recent Jordan River restoration project (located at 5200 S).

**Toe-wood structures** were used to stabilize 750 feet of eroding bank. Soil wrapped in coir fabric forms the new floodplain, which ranges from 20 to 60 feet deep. Altogether over 6,500 native trees and shrubs were planted in this reconstructed riparian area, and the upland was seeded with native grasses and wildflowers. TreeUtah pitched in to help plant 2,975 willows and 25 cottonwoods during two volunteer days.

Installed with one end extending out into the river, the structures catch the current to reduce its erosive force.

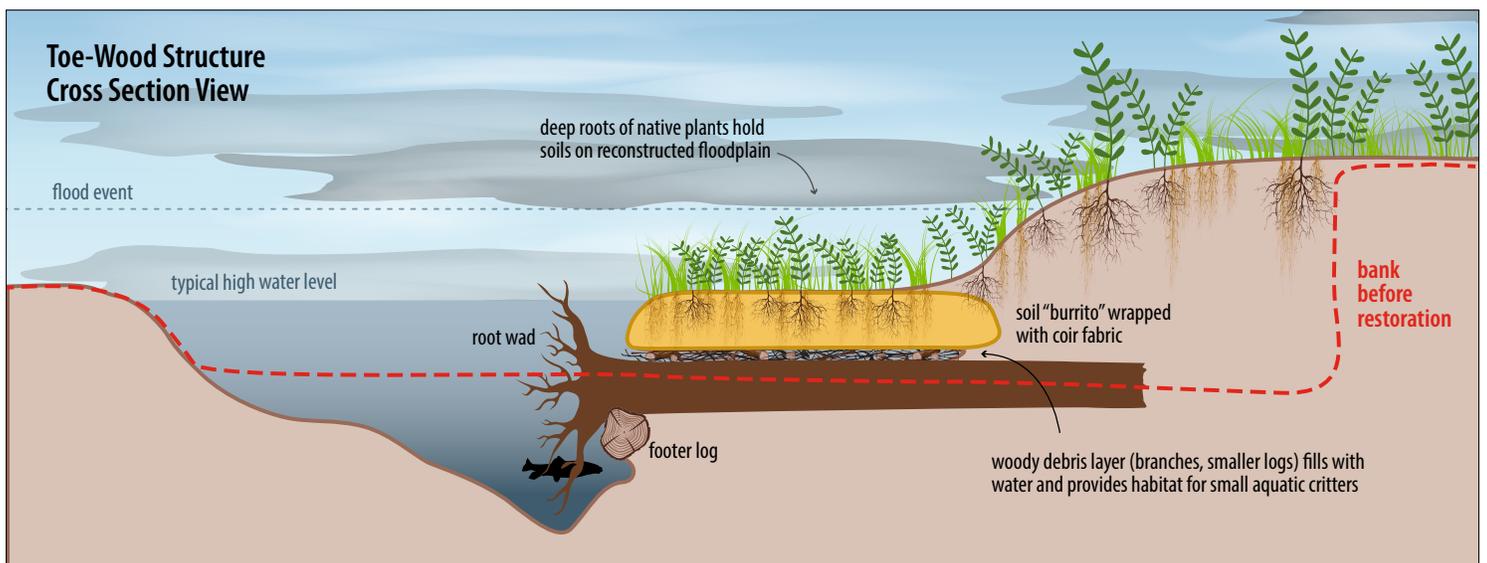
A toe-wood structure is used to restore a stream's ideal width and depth, provide valuable habitat, and create stable banks that are protected against excess erosion. It's a natural channel design technique that can replace expensive rock and bank hardening.

This protects the bank and while providing healthier fish habitats. The newly built floodplain will be able to accommodate higher river flows, allowing floodwaters to slow down and deposit their beneficial sediments. And the added foliage will provide "roughness" that also helps to dissipate the energy of floodwaters.

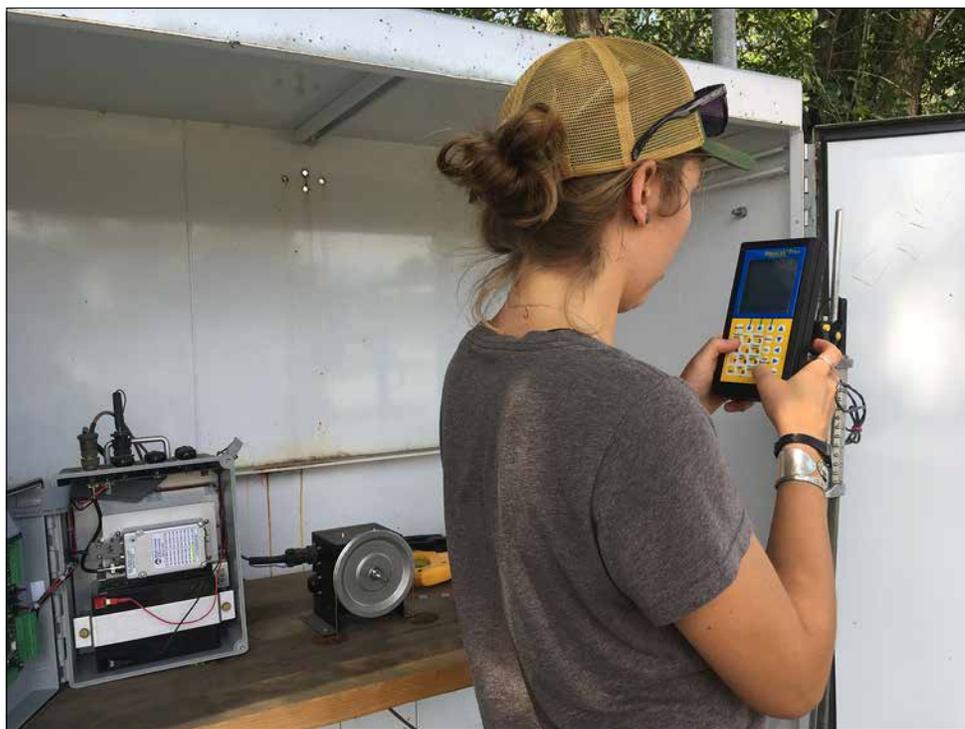
Watershed Program hydrologic technician comparing flow measurements taken in the creek to the most up-to-date rating curves (gage at 300 West on Little Cottonwood Creek).
