CHANNEL STABILITY EVALUATION & STREAM REACH INVENTORY

SALT LAKE COUNTY DEPARTMENT OF PUBLIC WORKS

STREAM BANK STABILIZATION
INVENTORY FOR LITTLE COTTONWOOD,
BIG COTTONWOOD, AND MILL CREEK

SEPTEMBER, 1984

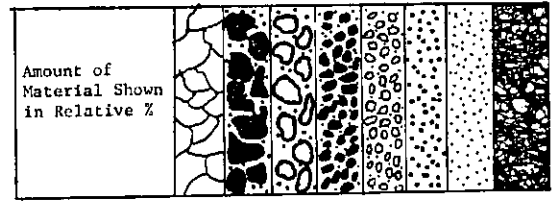
Size Composition of Bottom Material
 and Composite Stability Value

Size composition of bottom materials was observed and recorded. Figure 4, shows size composition for the creek. Few large or small boulders were found over the study area. Large rubble (6-12 inches) and small rubble predominated to Point 40. This observation corresponds to the higher channel gradients of the creek. Small amounts of deposition occur throughout this segment, particularly on the lower banks. However, much of this segment had recently been disturbed and it is to be assumed that existing deposition had been relocated or removed. Rifflepool conditions are located in this segment. Past Point 45, the channel gradient lessens and the creek meanders and is channeled into the Jordan River. Within this segment, the bottom consists mostly of deposited silt and muck with evidence of present dredging. The creek has been linear channeled below Point 64 and passes through meadow lands and vacant lots.
