**BOARD OF SALT LAKE COUNTY COMMISSIONERS  
PUBLIC WORKS DEPARTMENT**

**LEVEL II STREAM MORPHOLOGY CLASSIFICATION OF  
THE JORDAN RIVER IN SUPPORT OF THE JORDAN RIVER  
CHANNEL RESTORATION PROJECT**

**STEVEN F. JENSEN  
AND  
RACHEL FILLMORE**

**June 18, 1997**

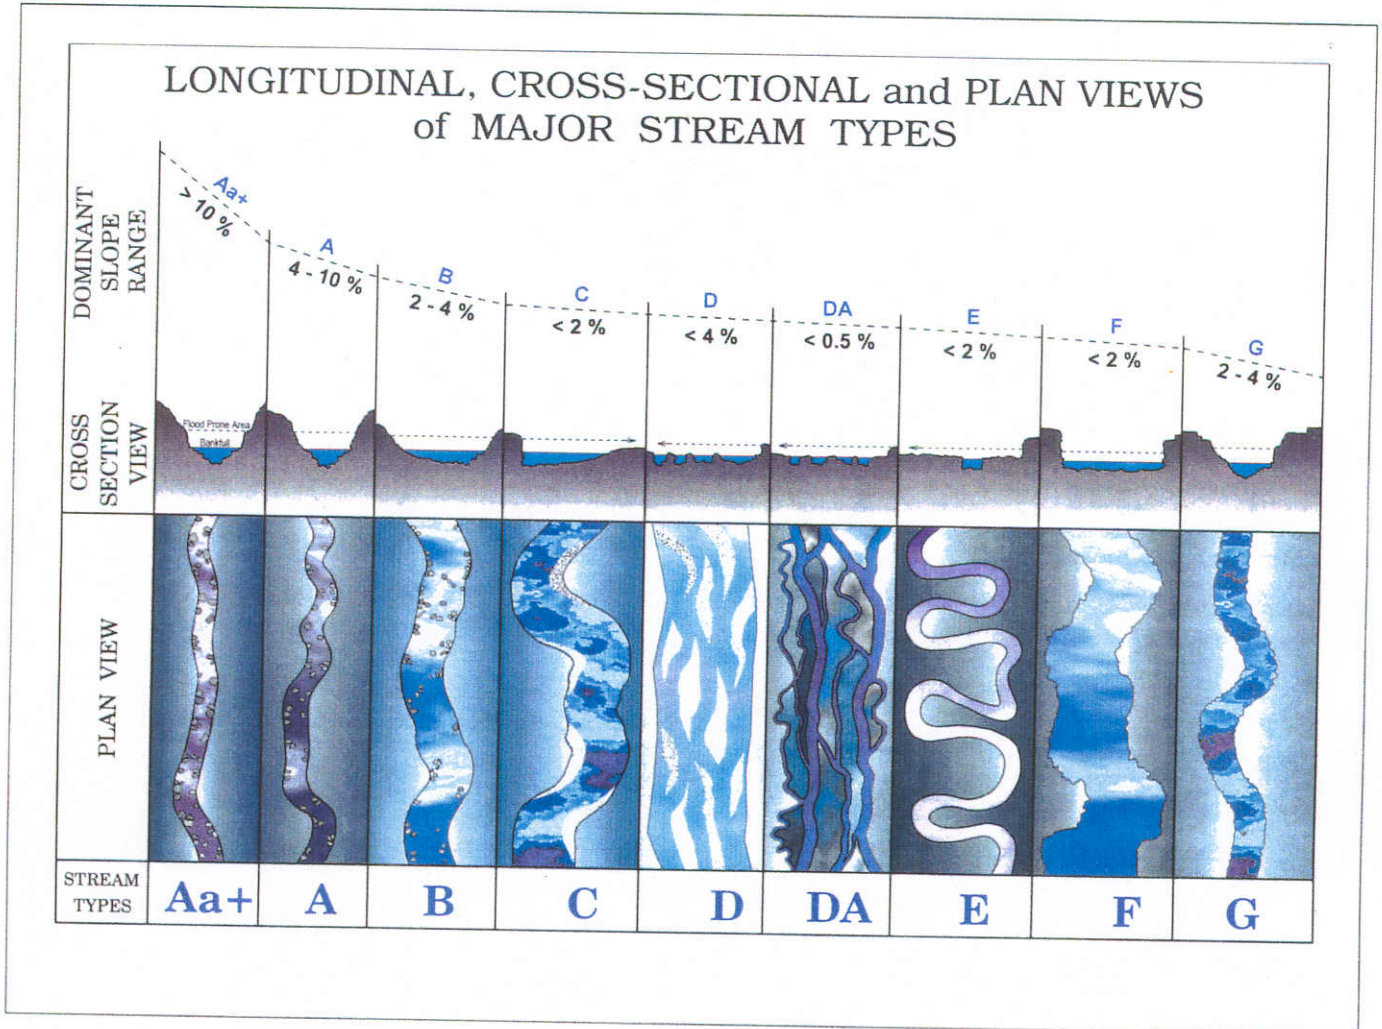
APPENDIX A--Figure 2-1: Level Classifications

LEVEL I: THE GEOMETRIC CHARACTERIZATION (1996, Rosgen 4-4)

Broad level stream classification delineation showing longitudinal, cross-sectional, and plan-views for major stream types

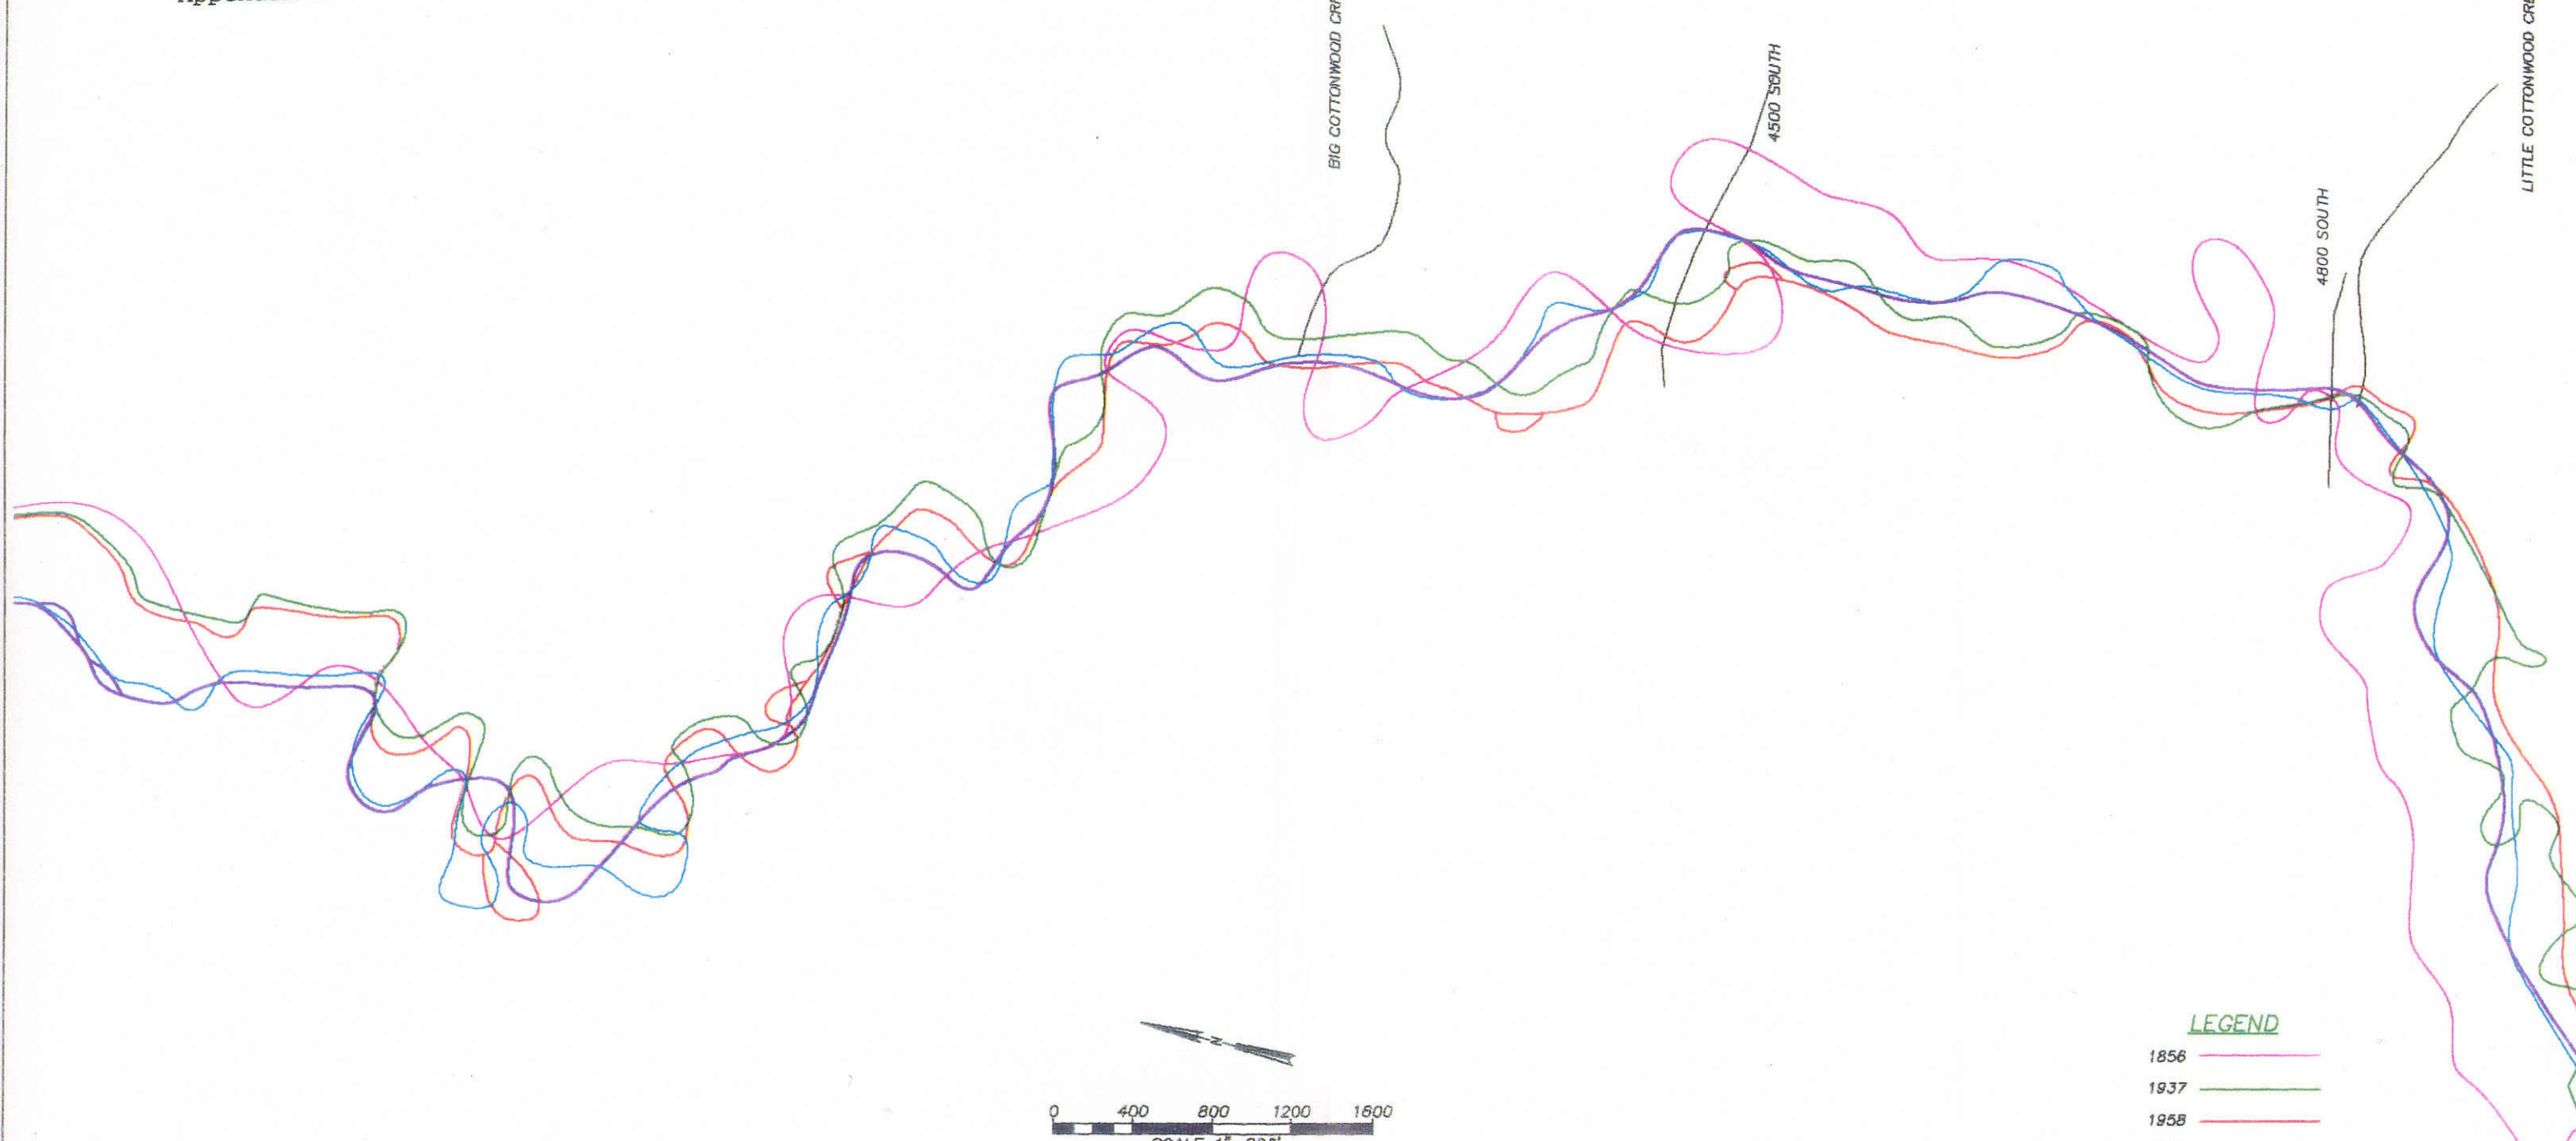
Figure 1-2  
 JORDAN RIVER CHANNEL  
 LOCATIONS 1856-1990  
 JORDAN RIVER STABILITY STUDY

- 1856 —
- 1937 —
- 1958 —
- 1982 —
- 1990 —

The Jordan does not fit neatly into any of Rosgen's categories because it is no longer a natural river. For example, all of the sections that show as B4 sections lack the narrow valley topography that is definitive of B type rivers. This raises a red flag of caution. It is more likely that these section are a degraded forms of another type of channel that now exhibit some B type features. Another example of misfit is that all of the C sections with the exception of Reach 8 have a sinuosity that is too low. C type streams normally exhibit a sinuosity level above 1.4 and all of these reaches are under 1.1. This lack of sinuosity also indicates a degraded channel. A historical analysis was performed using information from the CH<sub>2</sub>MHill's Stability Report, maps in CH<sub>2</sub>MHill's Attachment 1 for that study, and application of Rosgen's criteria to the data available. (Appendix B, Figures 1 and 2).
