STREAM REACH INVENTORY AND CHANNEL STABILITY EVALUATION

Purpose: These procedures were developed to systemize measurements and evaluations of the resistive capacity of mountain stream channels to the detachment of bed and bank materials and to provide information about the capacity of streams to adjust and recover from potential changes in flow and/or increases in sediment production.

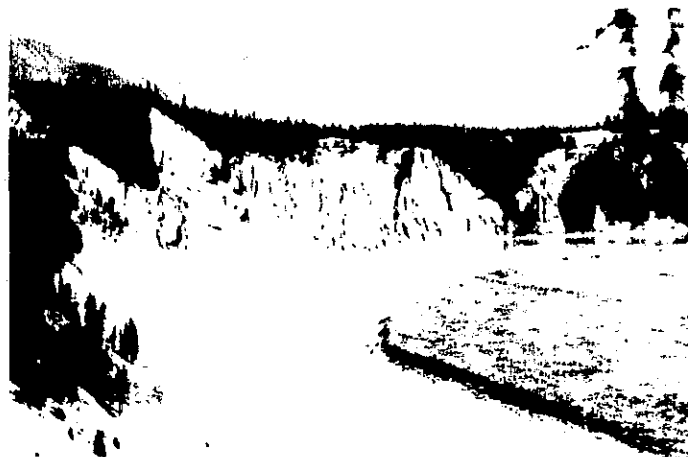
Mass wasting of slopes directed into the stream channel.

B. Mass Wasting Hazard: This rating involves existing, or potential detachment from the soil mantle and downslope movement into waterways of relatively large pieces of ground. Mass movement of banks by slumping or sliding introduces large volumes of soil and debris into the channel suddenly, causing constrictions or complete damming followed by increased stream flow velocities, cutting power and sedimentation rates. Conditions deteriorate in this element with proximity, frequency and size of the mass wasting areas and with progressively poorer internal drainage and steeper terrain:
